RE: December 2004 Monthly Report

1.5 Mile Reach Removal Action

GE-Pittsfield/Housatonic River Site

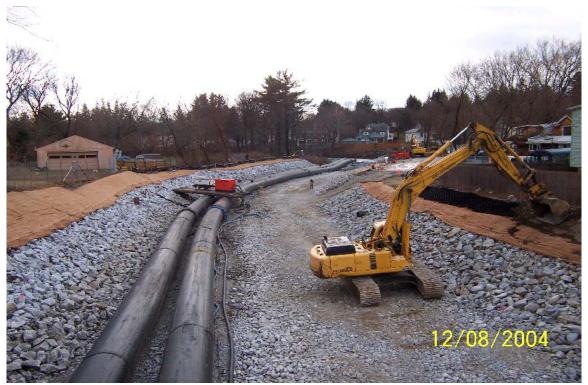
Photograph 1 – Cells 23W Riverbank Cellular Geoweb and Topsoil Installation

A 125-foot section of Cell 23W riverbank with slopes steeper than 2H:1V required cellular geoweb for riverbank stability purposes. The installation of the cellular geoweb on the Cell 23W riverbank was completed. Then, a minimum six-inch layer of topsoil was installed on all of Cell 23W riverbanks. Herbaceous seed mix and erosion control blankets were installed. Silt fencing was installed along the top of the riverbanks in Cells 23W as an erosion control measure.

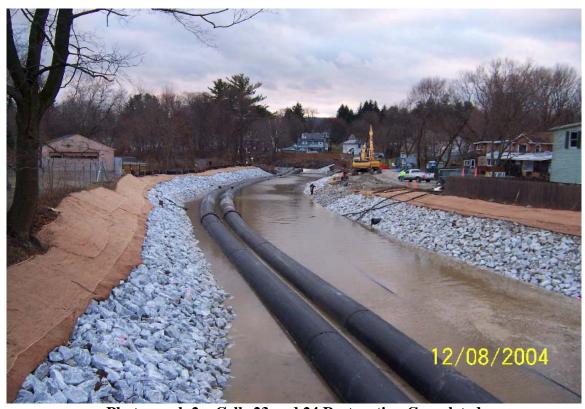
Photograph 2 – Cells 23 and 24 Restoration Completed

During the second week of December, all backfill activities in Cells 23W and 24W were completed. Backfilling was completed in accordance with backfill configurations described above. Once the backfilling operations were completed on the lower riverbanks in Cells 23W and 24W the temporary access ramp was removed from the Cell 24W riverbank.

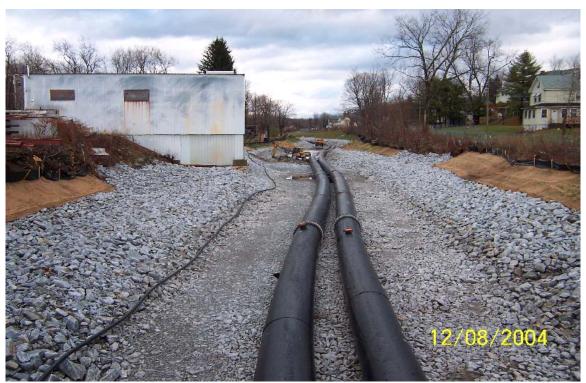
Photograph 3 – Overview of Restored Riverbed and Riverbanks upstream of Dawes Avenue Bridge

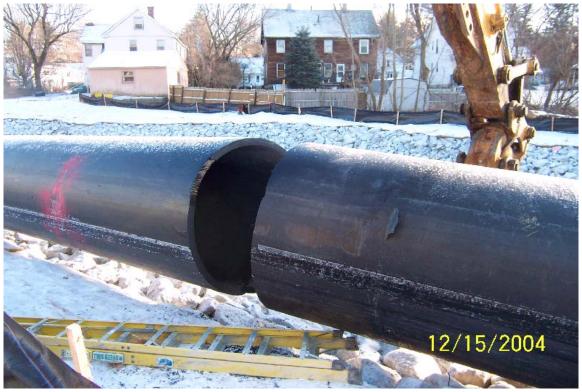
Photograph 4–54-inch HDPE Pipe Removal Test Cut

Also, during the third week of December, the 54-inch HDPE pipe removal test cut was performed. The slide gates to the 54-inch pipes were closed, the pipe was dewatered and stop logs were removed from the temporary dam to allow enough water to move the 54-inch pipe onto the Cell 24W riverbank. The pipe was then tied off to two sheet piles and a 150-foot piece of the pipe was cut using a chain saw. The cut pipe was then moved to Parcel I8-24-1 staging area by transporting the pipe up the river channel. The stop logs were placed back onto the dam after the pipe test cut was completed.

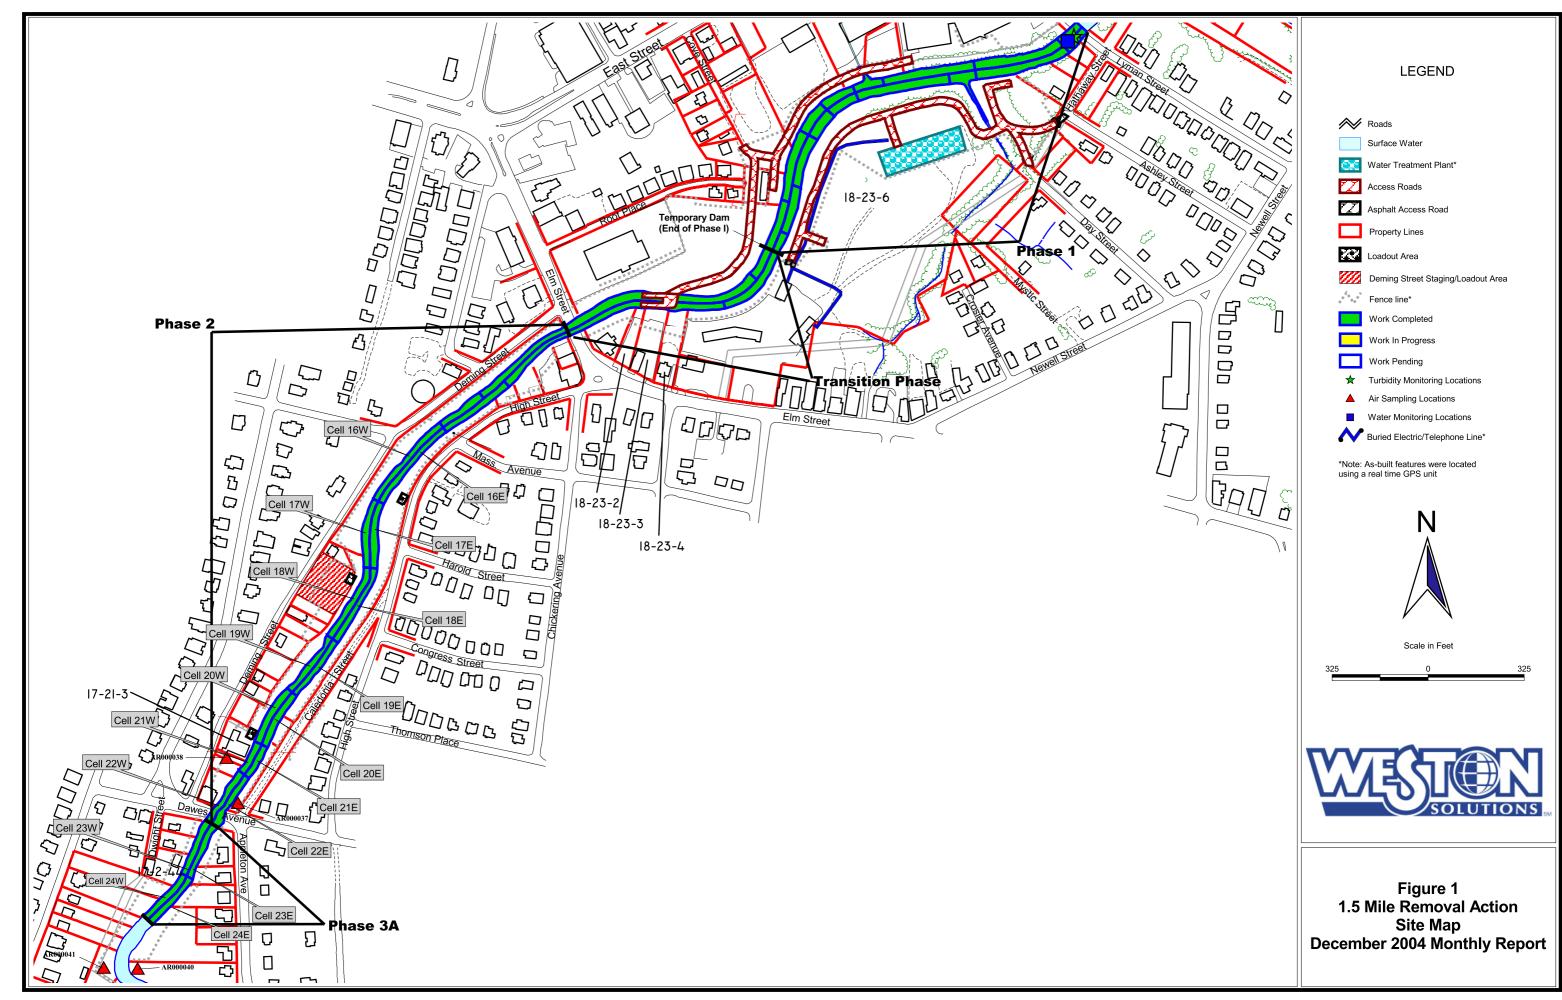
Figure 1 is a map of Phase 1, the Transition Phase, Phase 2 and Phase 3A and includes the layout of all excavation cells, temporary dam, water monitoring locations, air sampling locations, access road locations, excavation load out locations, staging area locations, fence line location, the water treatment system pad location, and the utility trench location.

Refer to Figure 1 for an orientation of the excavation cells and their respective locations.
